**Flood Control Project Maintenance
Levee Inspections**

Fall 2019 Levee Maintenance Deficiency Summary Report

Sacramento River Basin

Reclamation District No. 0070 Meridian

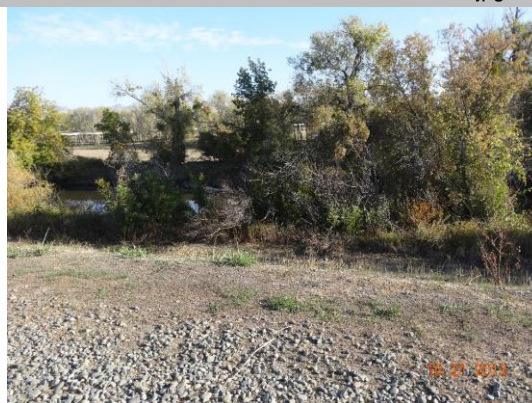
Photo 1 of 3 : UCIP_FA_2019_23463_40622.jpg

Comment Code					
Inspector Comment					
DS_ID:21347 FS_ID:23463 EP_NO: 3804 Repair Type: Non-Urgent Crossing Status: Indicator Found UCIP Comments: Unable to confirm if the indicators that were found in the field correspond to this crossing. Will need to contact PG&E to confirm location of crossing. Photos will need to be updated if the photos attach do not correspond to this crossing. This crossing is referenced in the USACE Periodic Inspection as item USACE_CESPK_MRD1_2012_p_0304 for 12 inch gas pipe. Coordinates between DWR UCIP and USACE PI are approximately 630 feet apart. FIELD_STRUCT_DESC: 12-inch coated steel natural gas pipeline through the levee, 3.6 feet below the crown. Concrete cutoff wall around the pipe at the center of the levee. Marker sign on the waterside (WS) shoulder. Rock revetment on the WS slope. (Plans for installation of a 12-inch gas collecting line through the levee authorized under Permit No. 3804, 1961 - Pacific Gas and Electric Company [PG&E]). [Additional Reference(s): DWR Levee Log, 2007]. FS Date: 10/21/2013

View of waterward side--no markers visible.

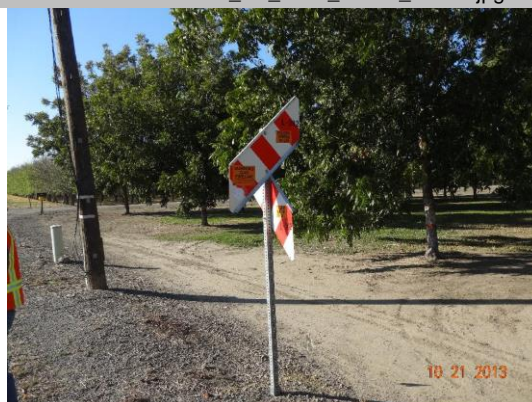
Photo 2 of 3 : UCIP_FA_2019_23384_40247.jpg

View of markers on the west side of S. Tarke Road.

Comment Code						
Inspector Comment						
DS_ID:21415 FS_ID:23384 EP_NO: 15936 Repair Type: Non-Urgent Crossing Status: Indicator Found UCIP Comments: No markers visible on levee slope or levee toe to indicate line crosses levee. Need to contact PG&E to confirm location through levee. Also need to confirm the emergency contact person for this crossing. FIELD_STRUCT_DESC: 8-inch steel natural gas pipeline through the levee, 2.5 feet below the crown. Gas line markers on the landside (LS). (Plans to remove an existing 16-inch pipe and install an 8-inch natural gas pipe to existing pipe within the 10-foot LS limits of the levee authorized under Permit No. 15936, 1992 - Pacific Gas and Electric Company [PG&E]). FS Date: 10/21/2013

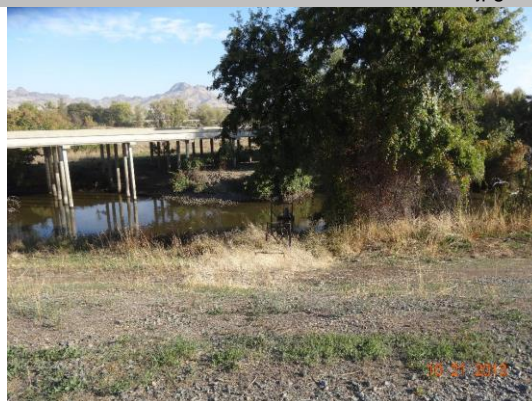
Photo 3 of 3 : UCIP_FA_2019_23503_40785.jpg

Comment Code						
Inspector Comment						
DS_ID:21351 FS_ID:23503 EP_NO: 3686 Repair Type: Non-Urgent Crossing Status: Found UCIP Comments: Dense vegetation limits the inspector's visibility to identify signs of pipe failure (leaks) along the waterward slope. Recommend removing vegetation along pipe alignment to conduct proper inspection of structure and appurtenances. Unable to find the gate valve on landward side. Walkway on waterward side in bad shape. This crossing is referenced in the USACE Periodic Inspection as item USACE_CESPK_MRD1_2012_p_0300 for 18 inch pipe. Pipe on LS is 10 inch not 18 inch. SEE UCIP DS_ID 21350 for details pertaining to 18 inch pipe. FIELD_STRUCT_DESC: 10-inch irrigation discharge pipe of an unknown material through the levee, 14.8 feet below the crown. Electrical conduit through the levee, 1 foot below the crown. Pump on a pile structure in the stream. Service pole with meter and control panel at the landside (LS) toe. Slide gate with walkway on the waterside (WS) end. Gate valve on the LS end, not found during 10/21/2013 pipe inventory. Rock revetment on the WS slope. (Plans for removal of a pump on the LS and installation of a pump and two concrete piers on the WS authorized under Permit No. 3686, 1961 - Gerald A. Frye). [Additional Reference(s): DWR Levee Log, 2007]. FS Date: 10/21/2013

View of waterward side--dense vegetation along slope.

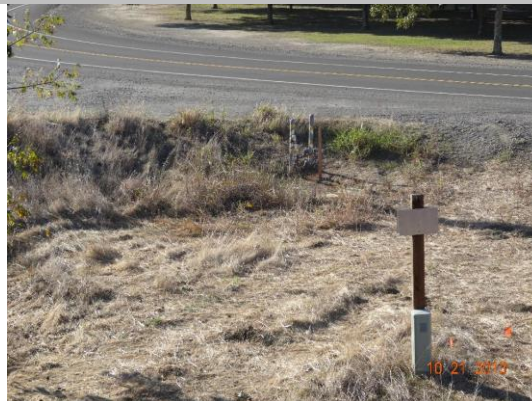
Photo 2 of 3 : UCIP_FA_2019_23467_40641.jpg

Additional appurtenances for gas line located at landward side near S. Tarke Rd.

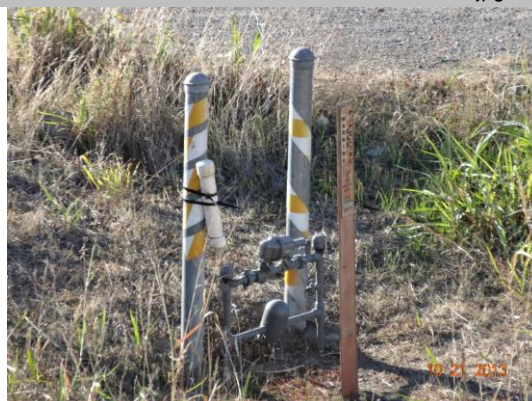
Photo 3 of 3 : UCIP_FA_2019_23467_40640.jpg

Comment Code						
Inspector Comment						
DS_ID:21354 FS_ID:23467 EP_NO: 14802 Repair Type: Non-Urgent Crossing Status: Indicator Found UCIP Comments: Need to contact owner to determine status of crossing. Need date of last inspection and confirmation that crossing is still in operable condition. Markers found about 159 feet upstream of coordinates at the crossing of the ramp and S. Tarke Road (39.142684, -121.842685). FIELD_STRUCT_DESC: 4-inch steel natural gas pipeline through the levee, 2.5 feet below the crown. Aluminum pipe marker on the landside (LS) slope. Emergency contact information for Pacific Gas and Electric Company (PG&E): (800) 344-4749? or 4742? or (916) 742-3251. (Plans to replace an existing 3-inch natural gas main through the levee with a new 4-inch steel pipe authorized under Permit No. 14802, 1987 - PG&E). [Additional Reference(s): DWR Levee Log, 2007]. FS Date: 10/21/2013

Close-up of the additional appurtenances for gas line located landward side.

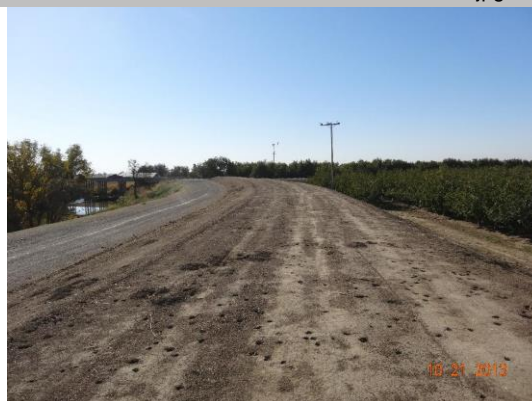
Photo 3 of 3 : UCIP_FA_2019_23526_40940.jpg

Comment Code					
Inspector Comment					
DS_ID:21355 FS_ID:23526 EP_NO: 9961 Repair Type: Non-Urgent Crossing Status: Found UCIP Comments: Dense burrow activity present on both waterward side and landward side. Recommend addressing burrow activity at this location. Also recommend having owner clear vegetation blocking access along walkway. This crossing is referenced in the USACE Periodic Inspection as item USACE_CESPK_MRD1_2012_p_290. FIELD_STRUCT_DESC: 10-inch (not 12-inch as referenced in the permit) steel irrigation discharge pipe through the levee, 5.4 feet below the crown. Siphon breaker in a corrugated metal pipe (CMP) riser on the landside (LS) slope. 24-inch concrete standpipe at the LS toe. Walkway to the pump on a pile structure in the stream. (Retention of a 12-inch steel irrigation pipe through the levee, 5.4 feet below the crown, a walkway to the pump on a pile structure in the stream, and a siphon breaker in a CMP riser on the landward slope authorized under Automatic Board Order (ABO) issued as Permit No. 9961, 1974 - Louis Tarke, Trustee). [Additional Reference(s): DWR Levee Log, 2007]. FS Date: 10/21/2013

View of levee crown and waterward berm looking upstream from crossing.

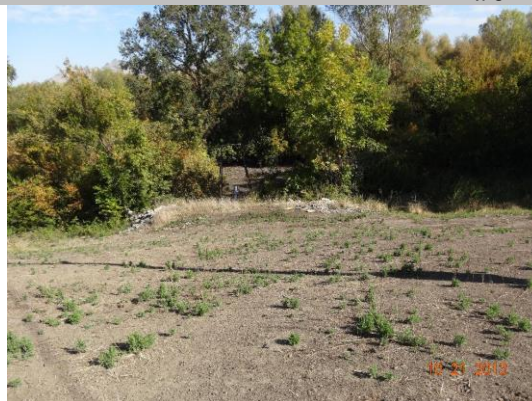
Photo 3 of 3 : UCIP_FA_2019_23508_40820.jpg

Comment Code						
Inspector Comment						
DS_ID:21336 FS_ID:23508 EP_NO: N/A Repair Type: Non-Urgent Crossing Status: Found UCIP Comments: Need to find owner to determine if crossing is still in use. If crossing is no longer in use owner will need to coordinate with DWR inspector and CVFPB to remove according to Title 23 requirements. Evidence of high burrow activity on waterward side recommend addressing issue. This crossing is referenced as USACE_CESPK_MRD1_2012_p_0230 in the USACE's PI report for no USACE recommendation letter available -- correction pipe is 12-inch not 16-inch. FIELD_STRUCT_DESC: 12-inch irrigation discharge pipe of an unknown material through the levee, 4 feet below the crown. Siphon breaker on the landside (LS) slope. 7-foot by 9-foot concrete distribution box at the LS toe. Service pole on the waterside (WS) slope. Pump on a concrete sump on the WS slope. Overhead power line crosses the levee. (Plans for the installation of a 12-inch steel irrigation pipe through the levee authorized under Permit No. 613, 1934 - Waldo M. Nall. Plans to retain a 12-inch pipe through the levee, 4 feet below the crown, pump, and siphon breaker authorized under Automatic Board Order (ABO) issued as Permit No. 9948, 1974 - Edward E. and Doris M. Nall). [Additional Reference(s): DWR Levee Log, 2007]. FS Date: 10/21/2013

View of waterward side.

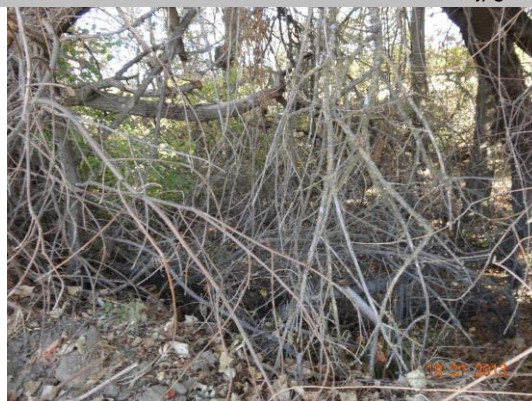
Photo 3 of 3 : UCIP_FA_2019_23530_40971.jpg

Waterward side covered by vegetation.

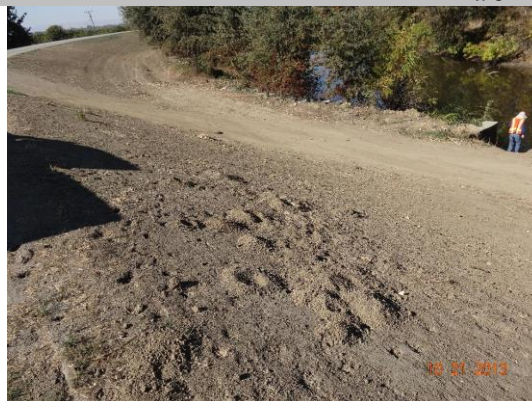
Photo 2 of 3 : UCIP_FA_2019_23506_40801.jpg

Recent burrow activity soil months next to holes.

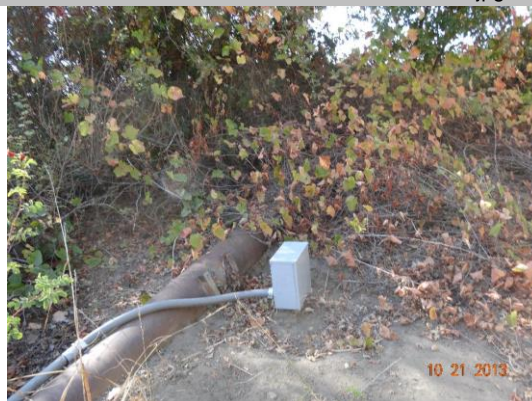
Photo 2 of 3 : UCIP_FA_2019_23519_40898.jpg

Pipe and electrical conduit exposed on levee berm.

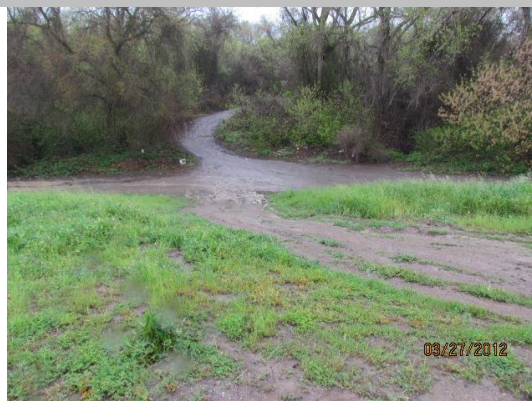
Photo 1 of 2 : FA_2019_RD0070_29_6_20190822_00001.jpg

View of vehicle erosion along the waterside slope.

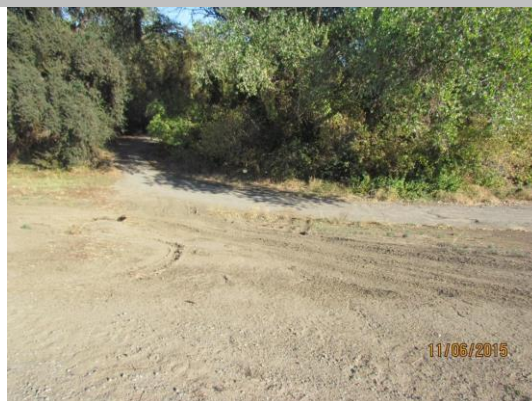
Photo 2 of 2 : FA_2019_RD0070_29_6_20190822_00002.jpg

View of the vehicle erosion along the waterside slope.

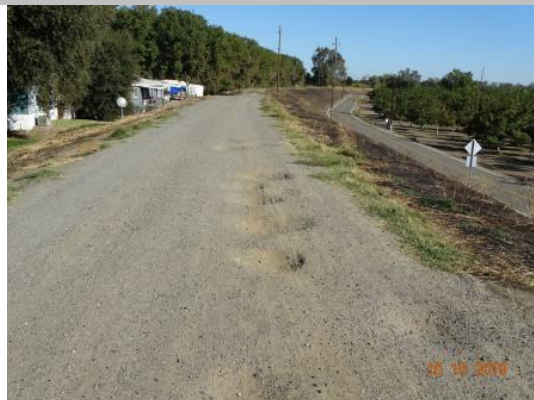
Photo 1 of 1 : FA_2019_RD0070_30_99_20191011_00131.jpg

View of the ruts in the crown surface. Fall 2019.

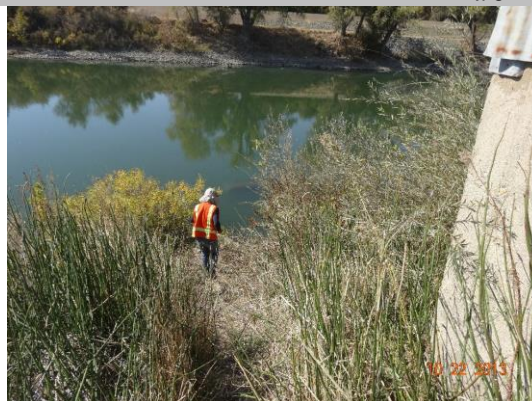
Photo 3 of 3 : UCIP_FA_2019_23891_41837.jpg

Dense vegetation covers pipe intake on waterward side.

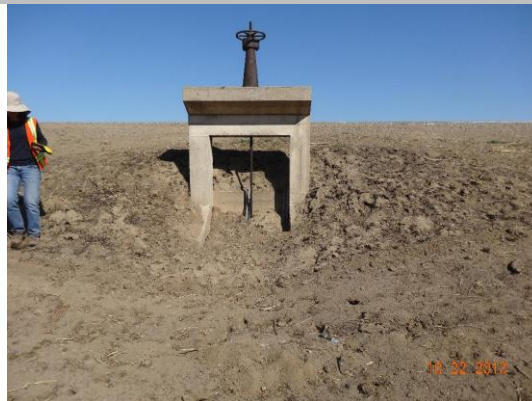
Photo 2 of 3 : UCIP_FA_2019_23892_41841.jpg

Buried screw gate located on waterward shoulder.

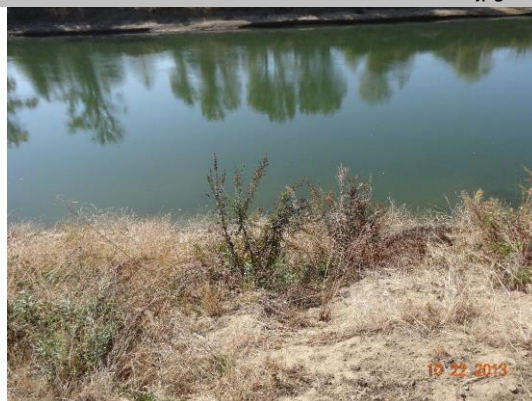
Photo 3 of 3 : UCIP_FA_2019_23892_41840.jpg

Dense vegetation on the waterward edge.

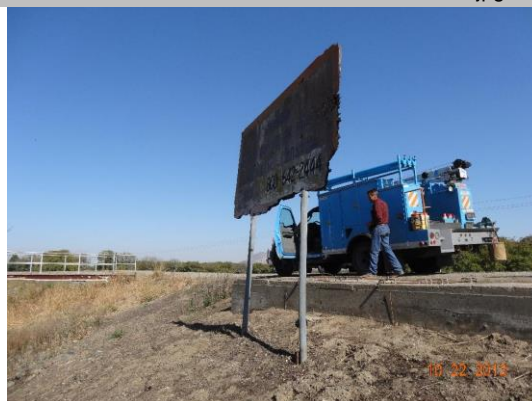
Photo 3 of 3 : UCIP_FA_2019_24165_42576.jpg

Gas line sign located on waterward side--sign in bad shape.

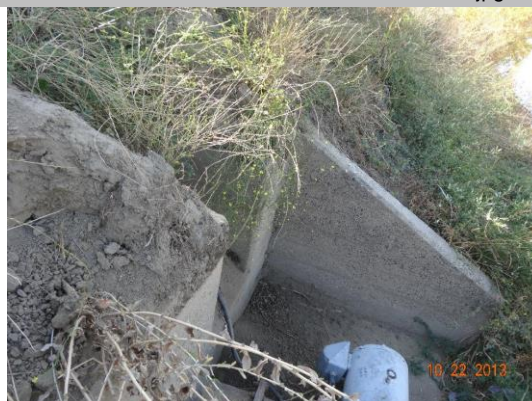
Photo 3 of 3 : UCIP_FA_2019_23964_42113.jpg

Crossing appears altered on waterward side.

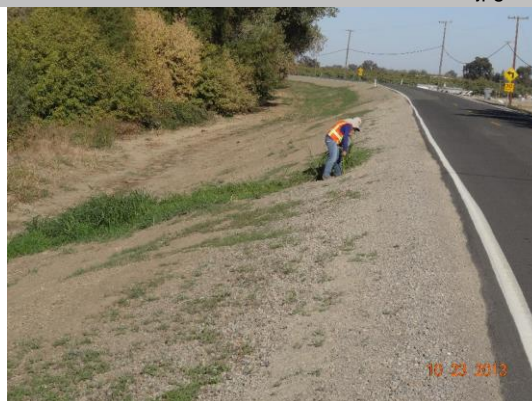
Photo 1 of 3 : UCIP_FA_2019_50007_42684.jpg

Vegetation on WS where leak found.

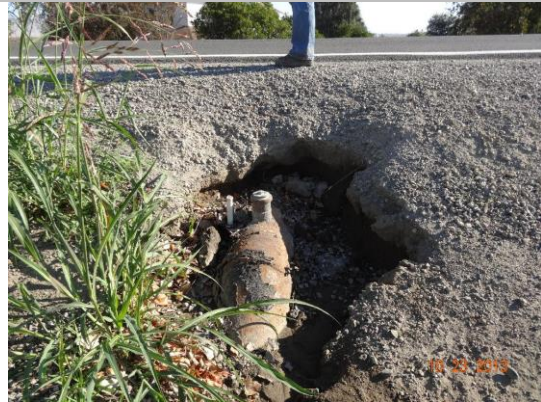
Photo 2 of 3 : UCIP_FA_2019_50007_42680.jpg

Damage to WS shoulder due to leaky pipe or siphon breaker.

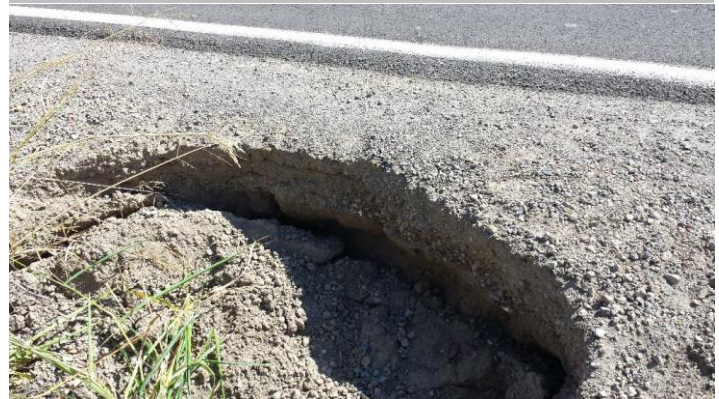
Photo 3 of 3 : UCIP_FA_2019_50007_74614.jpg

Slope damage within 2 feet of County Road.

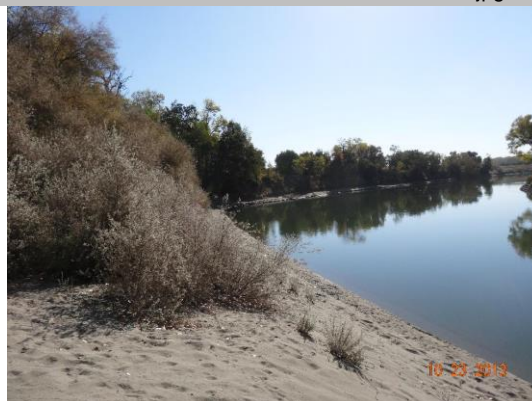
Photo 2 of 3 : UCIP_FA_2019_23967_42132.jpg

No pipe exists levee on waterward side only CMP riser present on landward side.

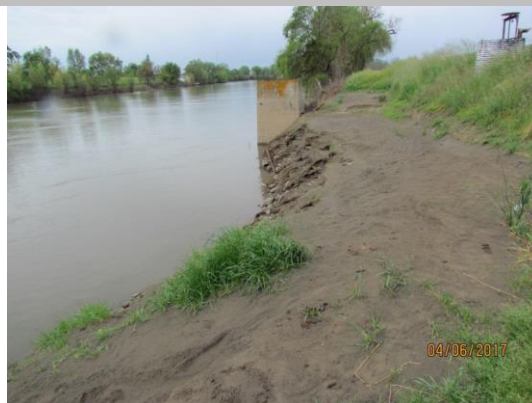
Photo 1 of 1 : FA_2019_RD0070_30_72_20190822_00014.jpg

View of the erosion along the waterside slope.
